## Walton Flood Commission Fosters Repairs to Third Brook

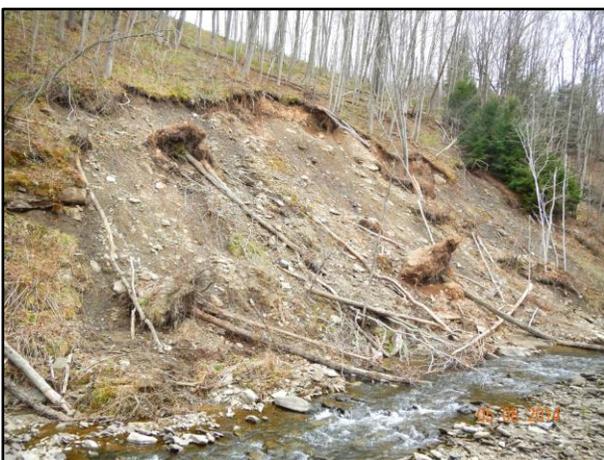
Portion of bank failure in early 2014, looking upstream.
