Getting to Know Your Streams and Stream Program

Delaware County, NY

Prepared by:
Delaware County Soil and Water Conservation District
in partnership with New York City Department of Environmental Protection

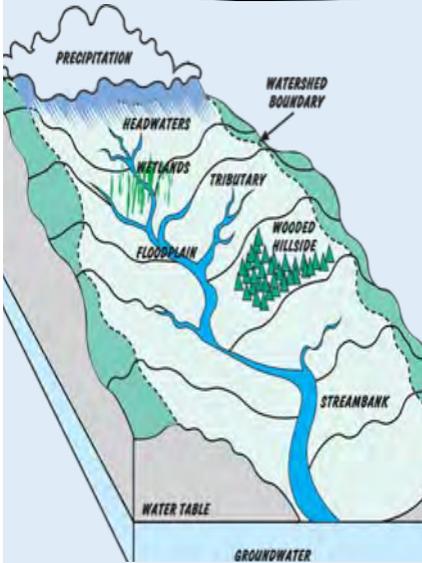
Illustration of a watershed (unknown source)

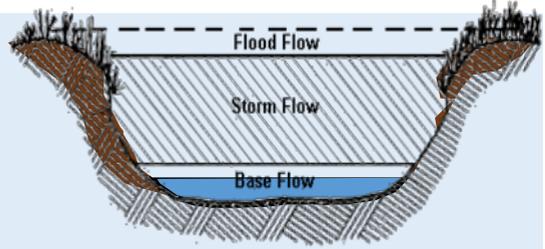
Illustration of a typical stream cross section showing stream flow (unknown source)

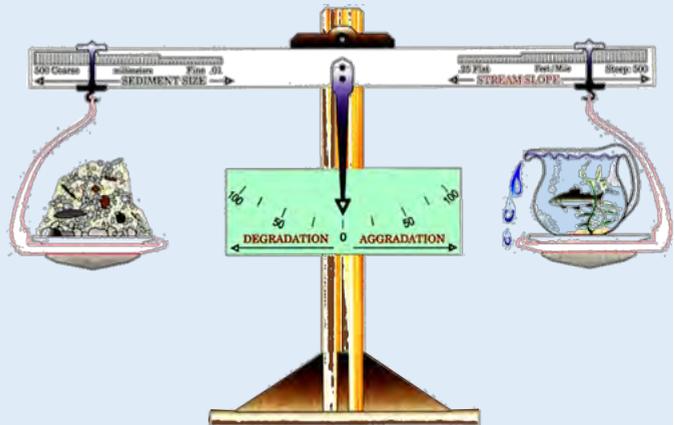
(Sediment LOAD) x (Sediment SIZE) ∝ (Stream SLOPE) x (Stream DISCHARGE)
Source: (Rosgen, 1996)

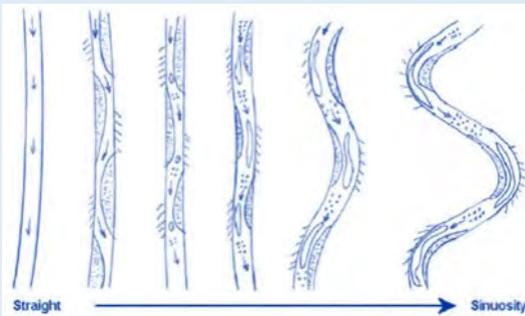
Figure A: Planform of a Stream with Increasing Sinuosity (After Keller, 1972)

Stream features are described in terms of their dimensions with regard to planform, profile, and cross-section. The planform is the path that the stream follows within its valley. A stream will have sinuosity (bending) as it meanders across the valley floor. Sinuosity is related to slope and energy. A stream that has high sinuosity will have a longer distance with a lower average slope than a stream that is straighter with a higher average slope. Profile dimensions of elevation and length are used to describe the slope and bed-form of a stream channel from top of the watershed to the mouth of the stream. Slope is a critical contributor to the energy of the stream. The energy of water flowing down a slope is needed to move sediment. A stream's slope can vary from high gradient (slope greater than 4%) to medium gradient (2-4%) to low gradient (less than 2%). The Figures A & B below show that the gradient is typically greatest at the top of the watershed and will gradually decline as the stream flows down the valley and makes its way to the bottom of the watershed where it has the lowest gradient.

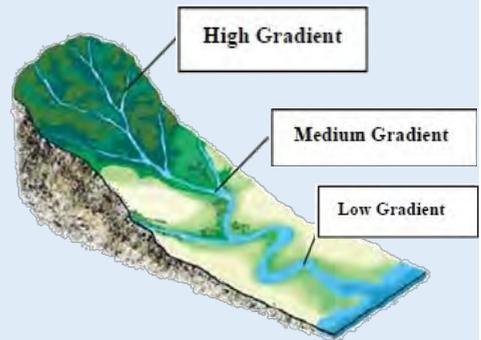
Figure B: Stream's slope from high gradient to low (unknown source)

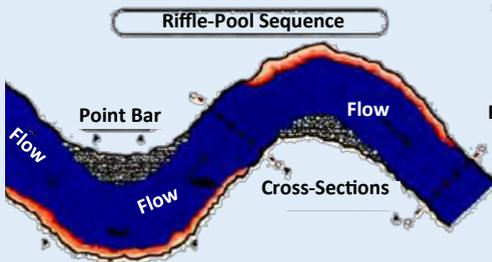
Typical riffle-pool sequence (Rosgen, 1996)

A wide variety of **stream channel types** can exist within the watershed, but there are two basic stream systems that can be easily identified in the field. A stream in a stable reach will maintain a balance in length to its riffle to pool ratio. **Riffle-pool sequence** are best recognized by their flatter valley bottoms, floodplains, meandering streams, and alternating riffles and pools. Pools are found on the bends in the stream and are features with lower slope and greater depth that act to slow the velocity of the water. The water enters the bend and creates a vortex-like helical flow that dissipates energy it spirals into the deeper water. Gravel can be found in the inside of the bend (as known as a point bar) which is a characteristic of a stable stream.

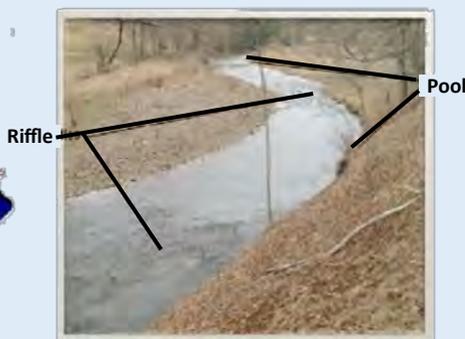
Riffle-pool sequence on Tremper Kill
Town of Andes

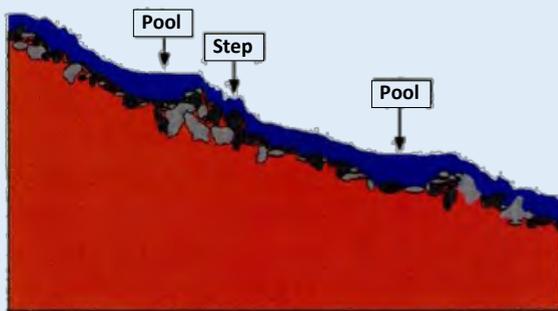
Typical step-pool sequence (Rosgen, 1996)

The second stream system is called a **step-pool sequence** and are typically found on steep narrow valleys or in the headwaters. The energy is dissipated through the step pools much like a series of speed bumps would slow down a car. Step-pools do not have floodplains.

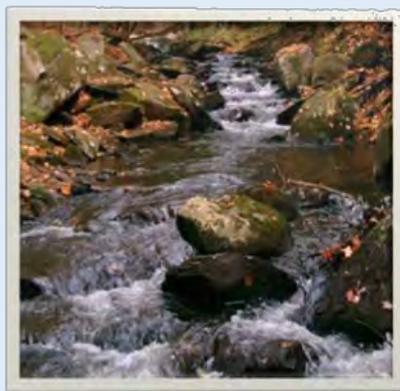
Step-pool sequence on Unnamed Tributary
Town of Walton

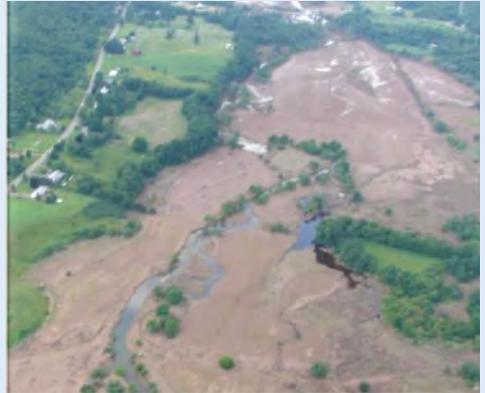
Ouleout Creek near Franklin, NY – 2006

A highwater event is not considered a bankfull flood event until the flow spills out of the streambank. Bankfull flow event is not considered a flood event until it overtops the banks. Bankfull happens on average, every 1.2 to 2 years and is largely responsible for the shape of the stream channel within the floodplain. These events determine the size of the channel that is needed to convey the water. The frequency of inundation within the bankfull channel is enough that the perennial vegetation, often, can't grow in the channel either because roots won't tolerate saturation and because seedlings are regularly swept away. The floodplain may be on one side or both sides of the stream, depending on the site. In areas that a the stream cannot access a floodplain on either side (but is doing so elsewhere along the stream), the channel is considered entrenched, or contained within its banks.

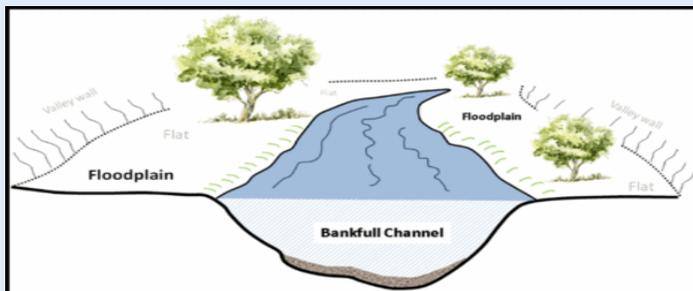
Illustration shows floodplains on both sides of the stream (unknown source)

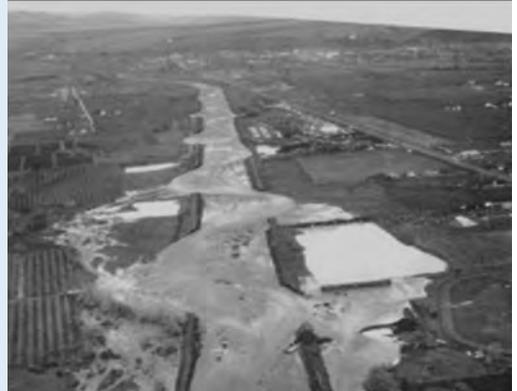
Flood damage on unknown stream (unknown source)

Notice how the river created bends to dissipate its energy and regains its floodplain.

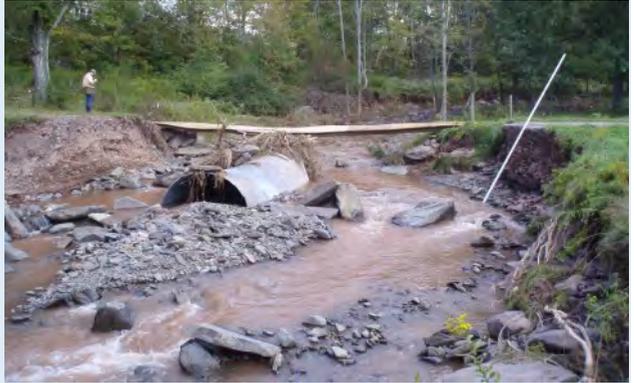
Undersize culvert damaged during 2011 flood event

If a bridge or culvert is undersized, the water and debris will be forced through the narrow opening concentrating the energy. If debris plugs the opening it will cause problems downstream and upstream of the structure similar to the picture to the right. Water becomes backed up behind the structure until water flows over the road and, sometimes, causes catastrophic failure of the structure and road.

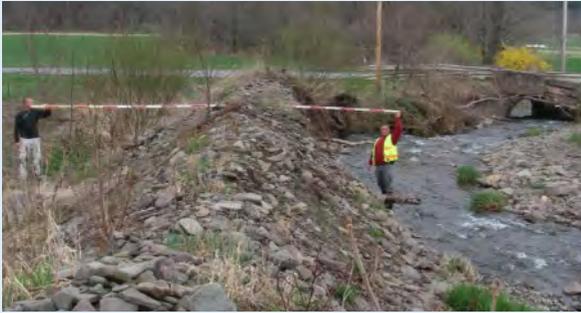
Undersize culvert on Mallory Brook, Town of Hamden

The culvert to the left is an example of an undersized culvert that is backing up water, causing the sediment to deposit upstream. The berm along the streambank is the result of past stream maintenance where gravel was dredged from the stream channel to prevent the road from flooding.

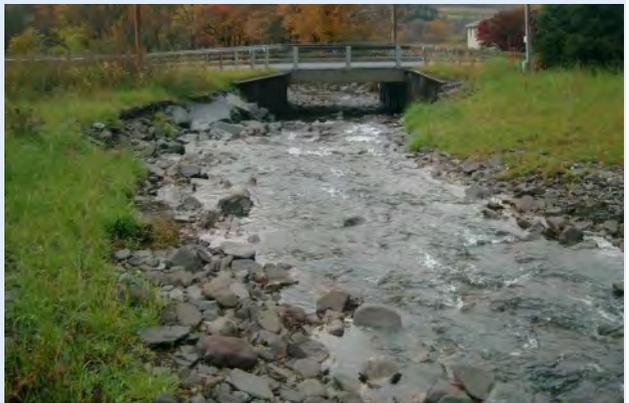
The photo to the right is at the same location as the above picture. The Town of Hamden received a grant in 2010 to replace the deteriorated culvert with a three-sided bridge and remove the gravel berms. Since its installation there has been no flooding on the town road. Delaware County Soil and Water Conservation District can provide technical assistance with proper culvert sizing and regulatory permit.

3-sided bridge on Mallory Brook, Town of Hamden

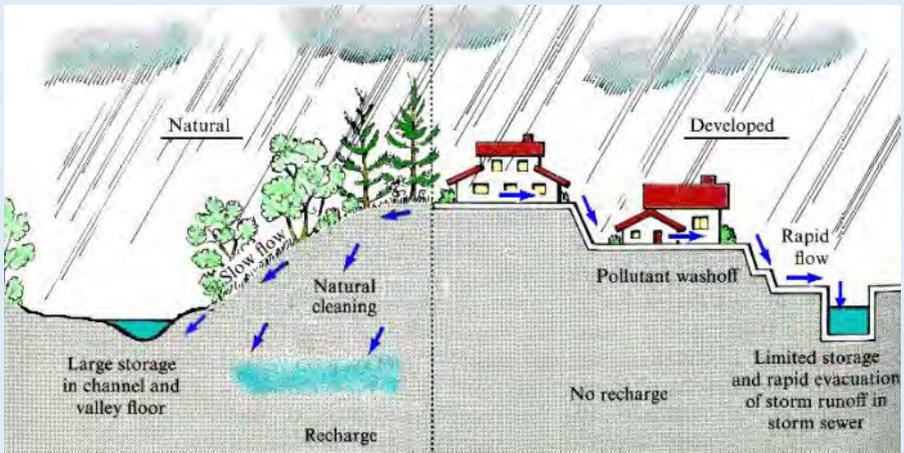
Natural vs. Developed Runoff (Dunne & Leopold, 1978)

Development of residential and commercial areas can have a significant impact on the watershed and on the ecology of the riparian (streamside) area. Buildings, roads and parking lots are most often made of hard materials that are commonly referred to as “impervious,” or incapable of absorbing water. These impervious surfaces do not allow for the rain water to soak into the ground. Rain water that is soaked into the ground can recharge the water table and slowly make its way back into the streams. In developed areas, the rain water is blocked from soaking into the ground. The mix of water and the pollutants known as “stormwater runoff” is concentrated and often runs directly into streams. Stormwater runoff in a natural landscape is compared to runoff in a developed landscape in the figure below. The rain water enters the stream system quicker in the developed areas which will result in the water rising faster with potential to increase flooding.

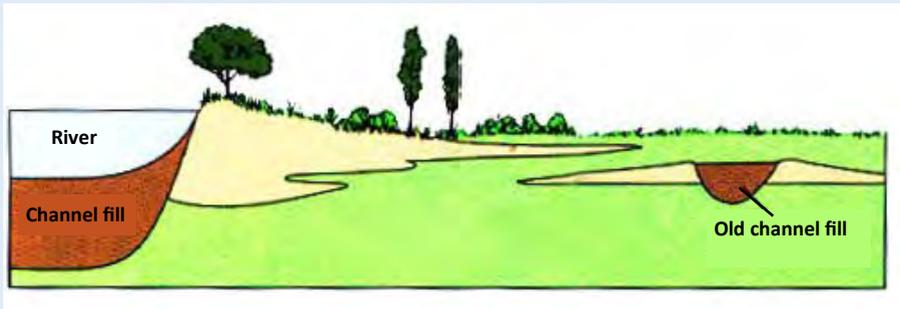
Stream that has been moved to higher elevation in a valley (unknown source)

The stream channel bed will fill with gravel because it doesn't have the stream slope and velocity to move the sediment causing erosion on the streambank to occur. The water will eventually push out of the streambank which typically happens during a storm event and flow to the lowest elevation of the valley. This type of erosion is known as an avulsion (or embayment).

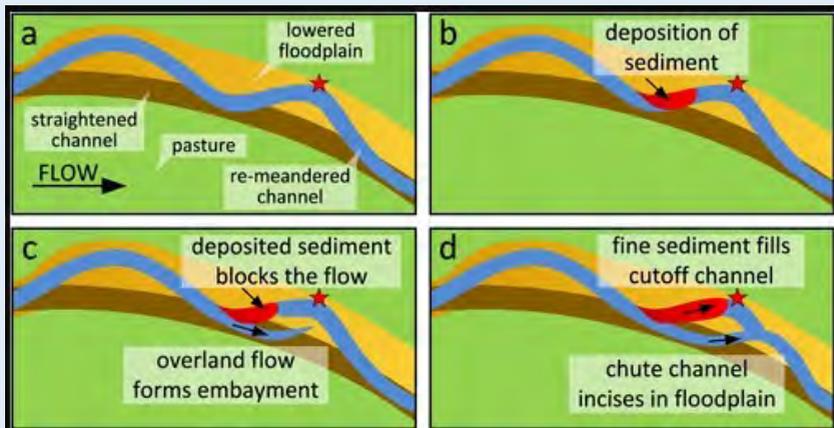
Illustration showing the evolution of improper stream maintenance (unknown source)

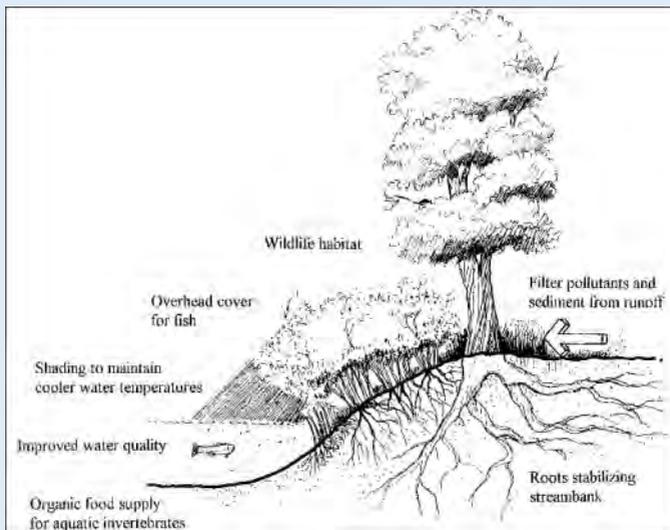
Figure 1: Schematic of a generic riparian buffer and its functions
(Source: USDA A Practical Streambank Engineering Guide, 1998)

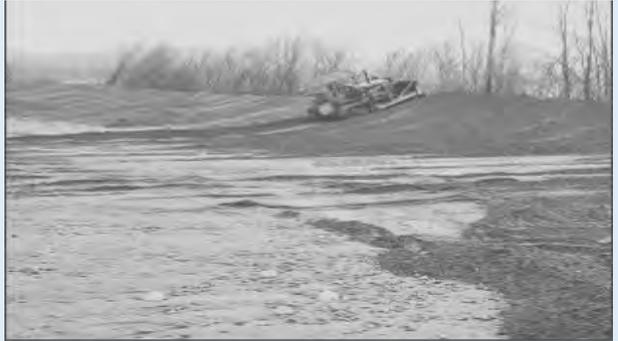
Historic photo of a parabolic stream channel (unknown source)

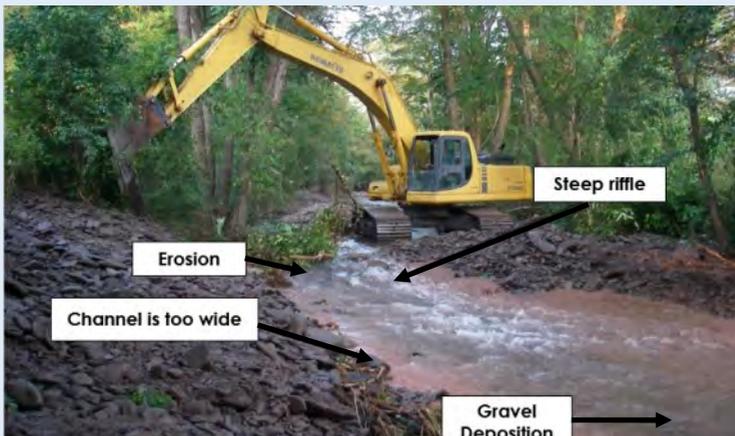
Photo on the left shows stream channel dredging on Bull Run during 2011 flood response.

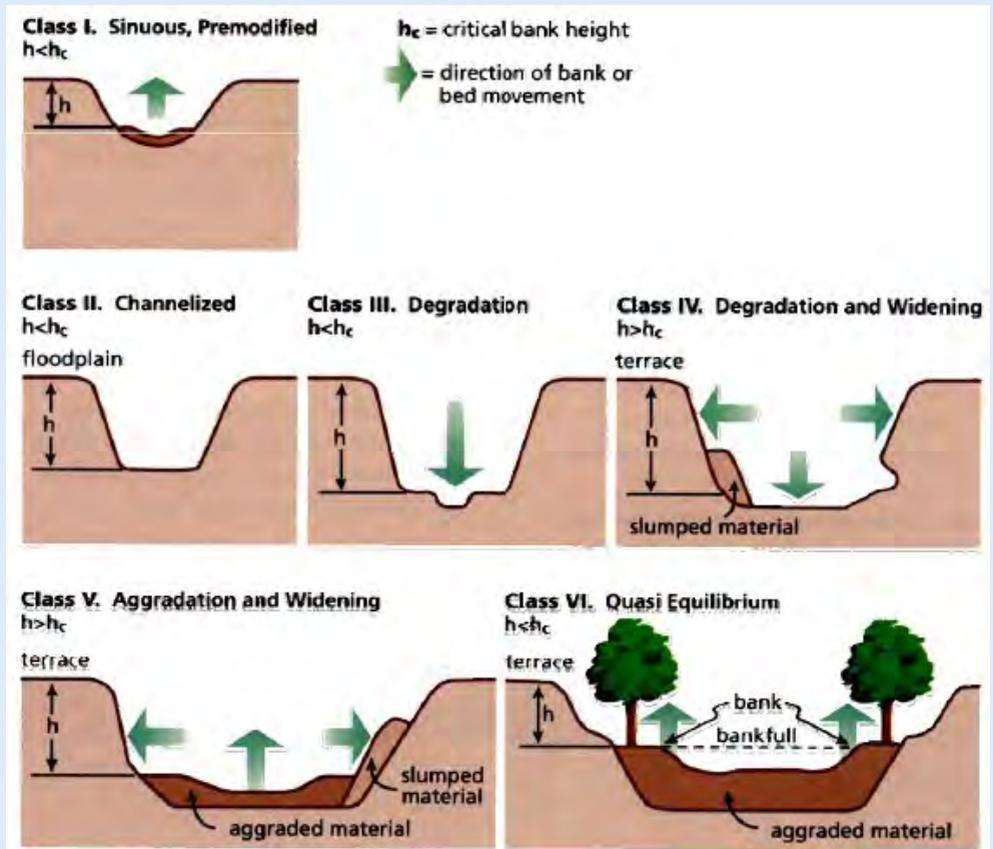
- Class I, stream channel in its natural pre-disturbed state.
- Class II, stream channel after being disturbed naturally or by dredging, presumably straightened and deepened
- Class III, the channel erodes deeper because the channel is no longer connect to its floodplain.
- Class IV, the channel starts to erode its streambanks because energy can no longer be dissipated on the floodplain.
- Class V, sediment deposits in the over-wide channel, and creates a new floodplain.
- Class VI, a new relatively stable channel is established with a floodplain within the original channel, and the former floodplain becomes a terrace.

Streams that have been disturbed by dredging, incision, straightening, or channelization follow a **systematic path to recovery**. This process has been documented in six classes described by Simon and Hupp (1992) shown in the illustration below. It is important to note that this process can also happen naturally, but accelerated with incorrect maintenance.

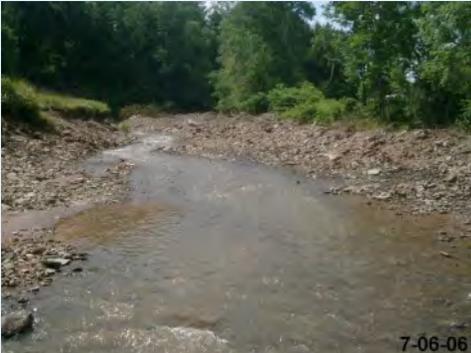
Photo 1 shows an area of stream **directly after a flood event**. This area appears to be in bad condition, but it is in relatively stable form. The gravel after a flood flow settles out into an overlapping or shingle-like effect wedging sediment material together. This interlocked material is less likely to move in a smaller storm event.

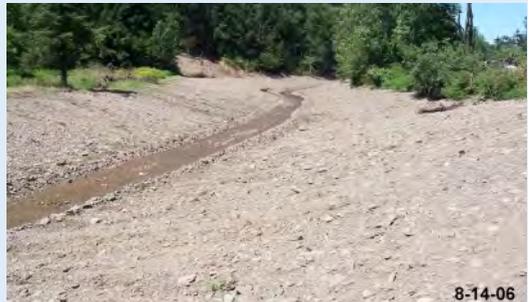
Photo 2 is in the same location **after post-flood work**, notice the straight and parabolic u-shape channel. Re-arranging the stream bed and banks loosened the sediment material allowing this material to be more easily transportable.

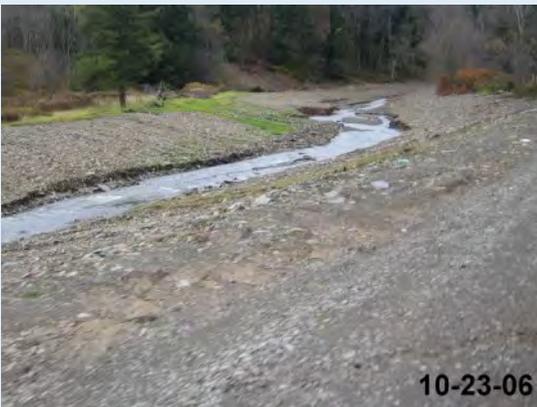
Photo 3 shows the stream channel **two months later**. Notice that the stream has begun to erode along its streambanks and become wider. The loose sediment is easily transported downstream. The stream will continue to adjust in order to establish an equilibrium and to create a new floodplain.

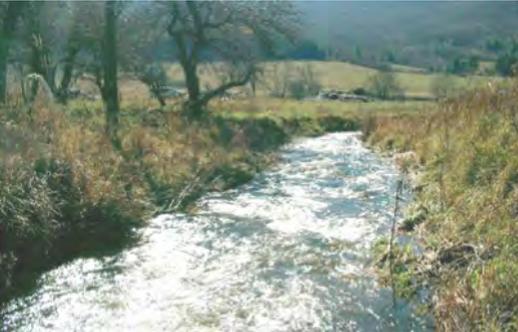
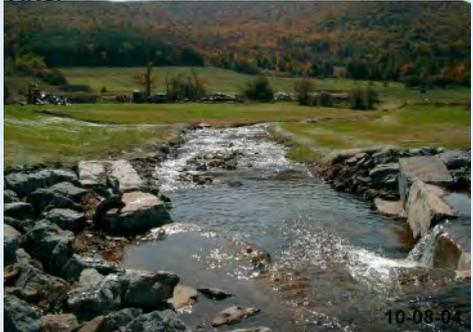
Delaware WB, Town Brook, Post Farm Repair (2004)

The first restoration project in the West Branch Delaware River watershed was completed in the Town of Stamford on Town Brook. The project length was 1200 feet and included thirteen rock cross vanes and eleven straight vanes that were incorporated along four constructed meander bends to assist in reducing shear stress and bank erosion.

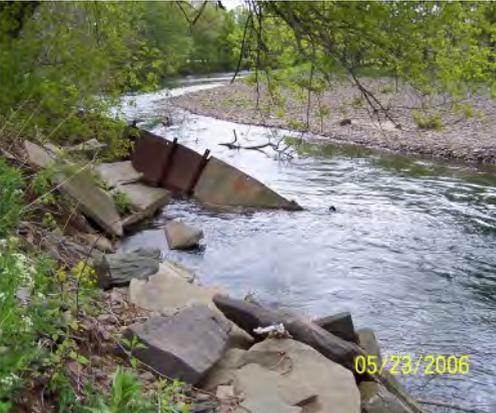
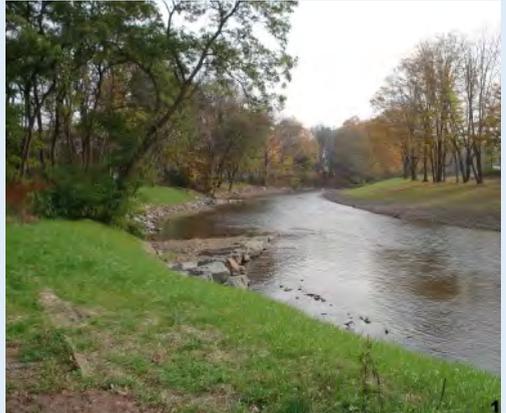
Delaware East Branch at Margaretville Fair Grounds (2008)

The first restoration project in the East Branch Delaware River watershed was completed in the Village of Margaretville. The project length was 900 feet to stabilize the channel alignment and dimensions using three rock vanes at a site where existing sheet piling was no longer functional as streambank protection.

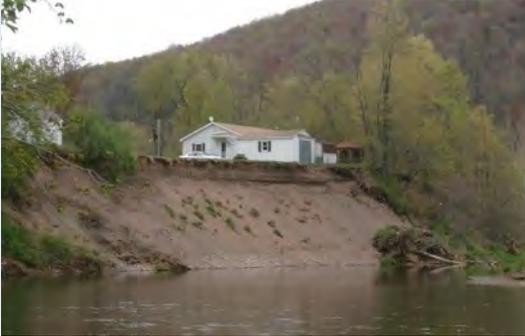
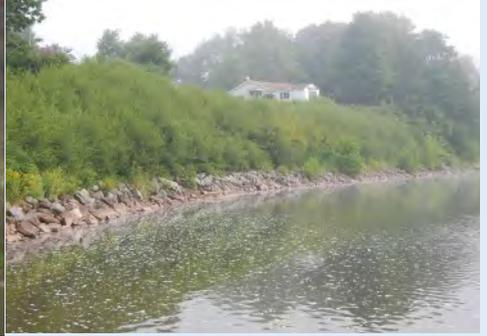
West Branch Delaware at Terrace Avenue (2008)

The reduction of erosion to the West Branch of the Delaware River was achieved by the installation of approximately 700 feet of rock riprap and a rock vane to direct stream flow energy toward the center of the river. In addition terraces were constructed on the bank above the stream surface for the purpose of installing plant materials for stabilization.

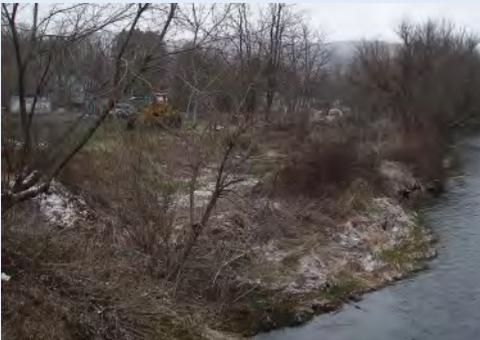
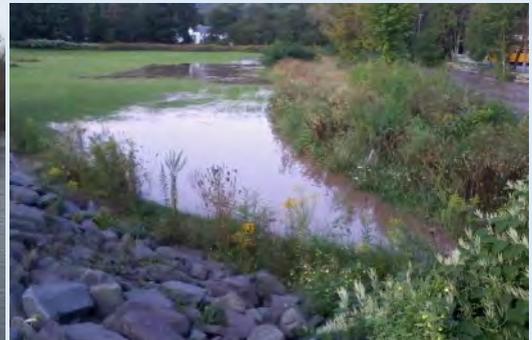
Floodplain Restoration at West Brook Restoration (2011)

To prevent further flooding of the Big M and Walton Central School, a floodplain reclamation project was constructed near the Sunoco gas station. Property was purchased by Open Space Institute and donated to the Village of Walton. Soil was removed to the proper elevation and tree/shrubs were planted along the streambank.

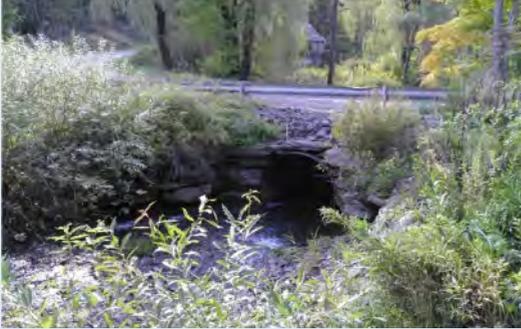
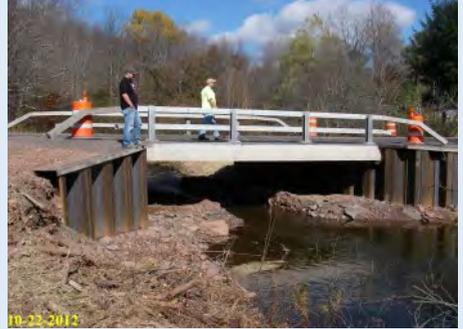
Roses Brook, Roxbury Mountain Rd. Culvert (2012)

This project is located in the Town of Stamford and was funded by a Delaware Watershed Stream Management Implementation Program (SMIP) grant that sought to replace an undersized round culvert with a three sided culvert to increase capacity and allow the structure to pass large storm flows. Delaware County Department of Public Works partnered with DCSWCD to design and construct the culvert.

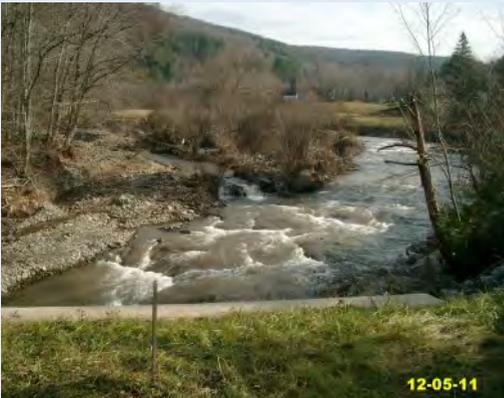
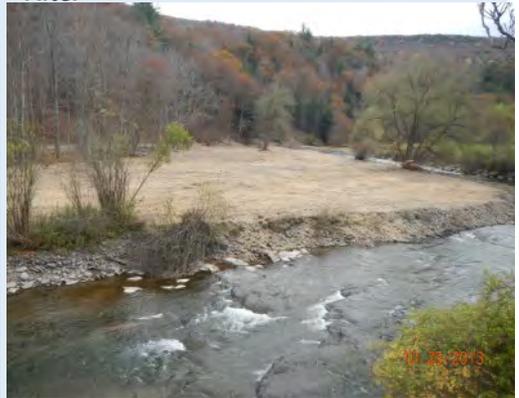
The DCSWCD regularly trains contractors, municipal highway personnel, and regulatory personnel to approach post-flood intervention in preparation for future floods. Part of this 2013 training was hands-on construction at a site located in the Town of Middletown. The project was implemented on Dry Brook to stabilize approximately 1,000 feet of an impaired channel by relocating the channel to its original location. The channel was re-sized using the Regional Bankfull Hydraulic Geometry Tables to establish the proper geomorphic size and shape, and restored access to the floodplain.

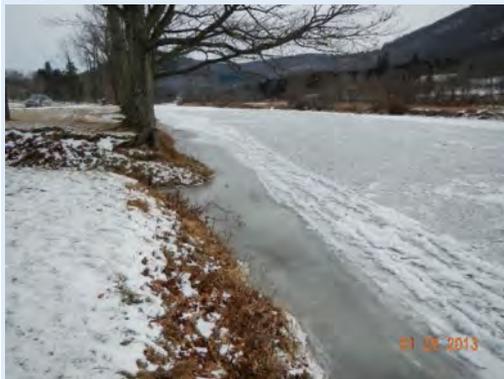
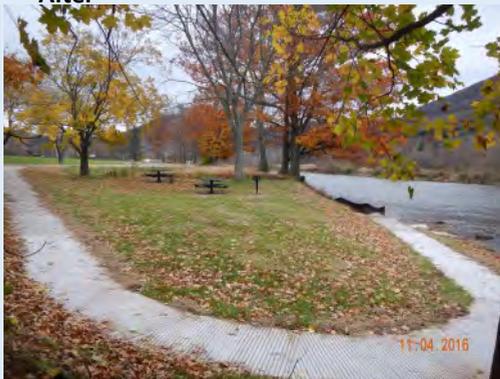
Ice House Boat Launch (2016)

This project is located in the Town of Walton funded under the Delaware Watershed Stream Management Implementation Program (SMIP) grant to provide river access with an “American Disabilities Act (ADA)” compliant concrete ramp. The project included a walkway to the boat launch as well as an informational kiosk.

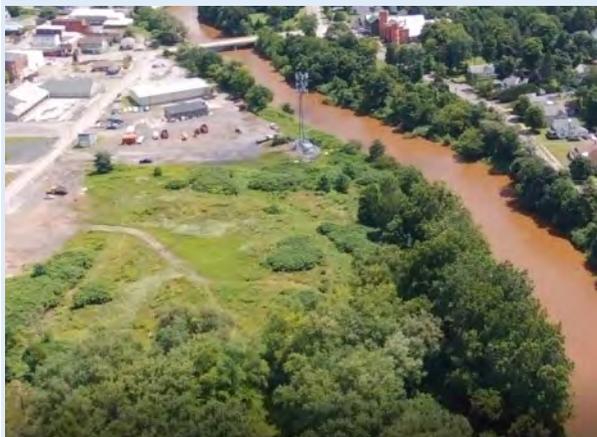
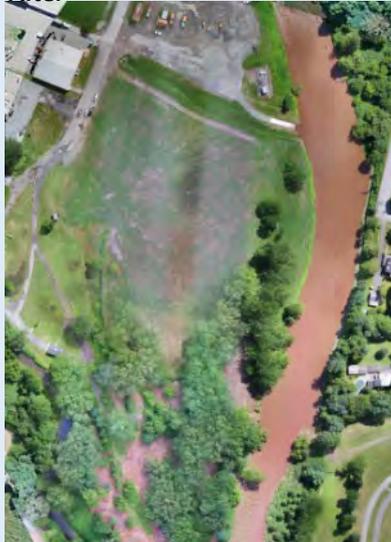
Floodplain Restoration at West Brook Restoration (2019)

This project consisted of the removal of approximately 52,000 cubic yards of fill material that was placed on the floodplain over the course of decades. Fill was moved to off-site locations in order to reclaim the floodplain and reduce flood water on Delaware Avenue. The work involved lowering the floodplain elevation by a maximum of 10 feet, with an average lowering of approximately, 4 feet.

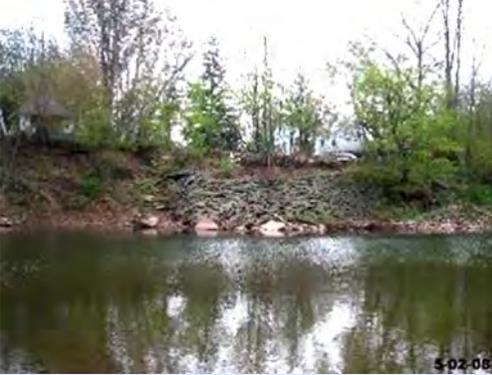
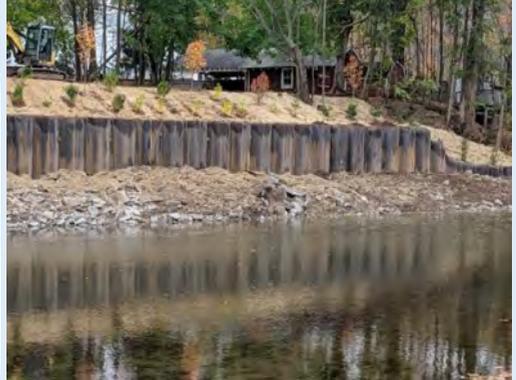
South Street Streambank Restoration (2019)

This project consisted of sheet pile driven deep below the streambed to address the mass wasting and rotational geotechnical failures causing the erosion of the existing streambank. A vegetated riprap toe was placed at approximately the bankfull elevation to resist erosive hydraulic forces, protect the stabilization material in front of the sheet pile, provide a more natural streambank, and limit the depth of the sheet pile and need for soil anchors. Joint plantings were used to vegetate portions of the rock toe above the ordinary high water mark to improve the aesthetics and provide some shade.

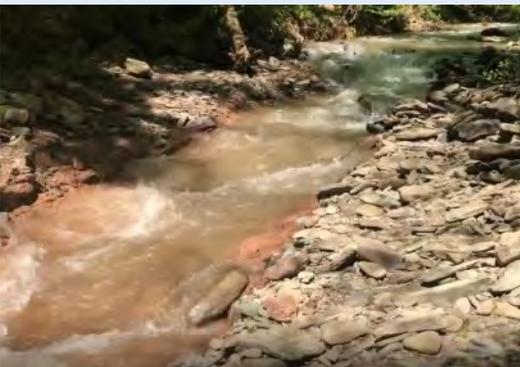
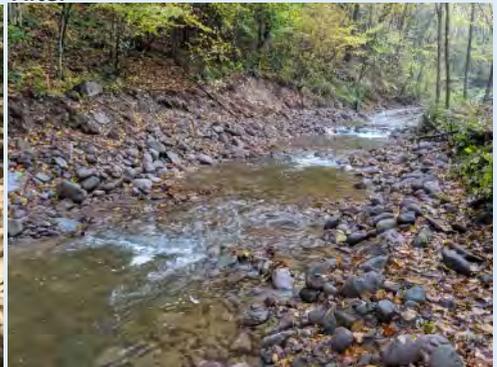
Marvin Hollow Streambed and Bank Stabilization (2019)

A localized storm event in 2019 led the Marvin Hollow streambed to headcut and scour approximately 2.5 feet down over 175 linear feet, exposing a layer of glacial till. This glacial till was comprised, almost entirely, of clay and silt and caused the stream to run turbid even at low flows. This water quality concern was remedied by elevating the streambed and installing step-pools to hold grade and dissipate energy.

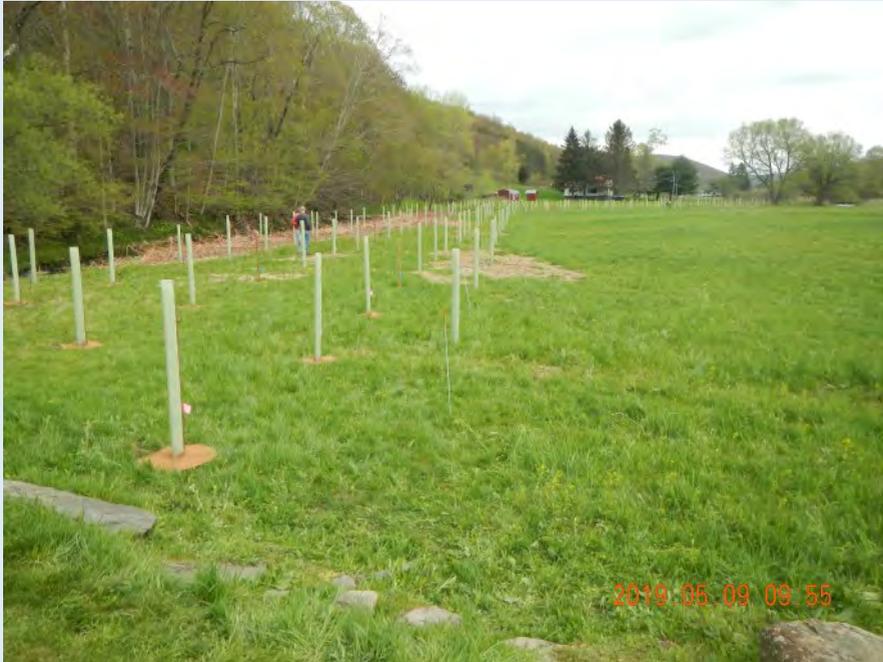
Photo: Siegel CREP/CSBI riparian buffer planting on East Brook in the Town of Walton.

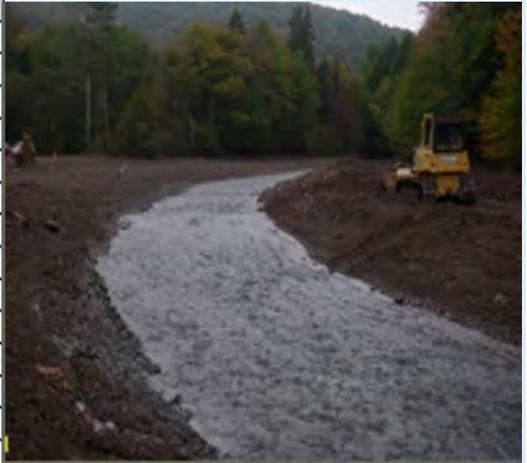
Photo above shows post-flood response after 2011 on Mill Brook after DCSWCD staff technical assistance with stream channel dimensions.

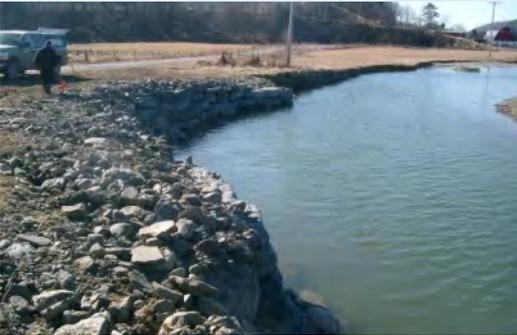
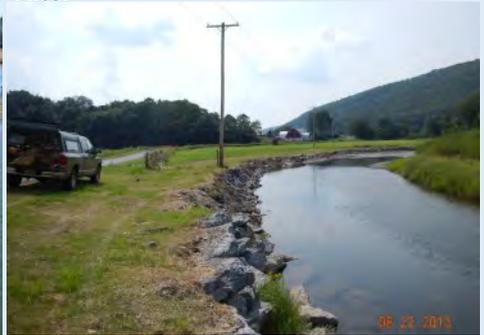
This project consisted of repairing an eroding streambank and removing excessive gravel deposition on Charlotte Creek. 500 linear feet of riprap was installed along the toe of the bank to protect the road and utility poles.

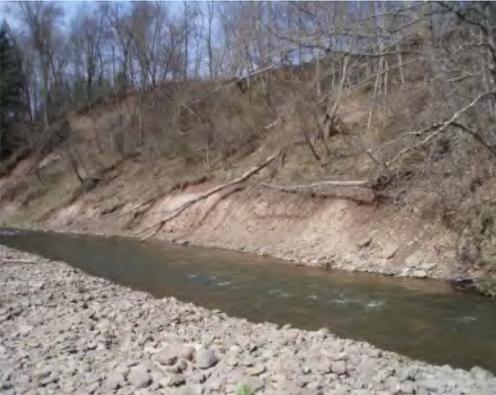
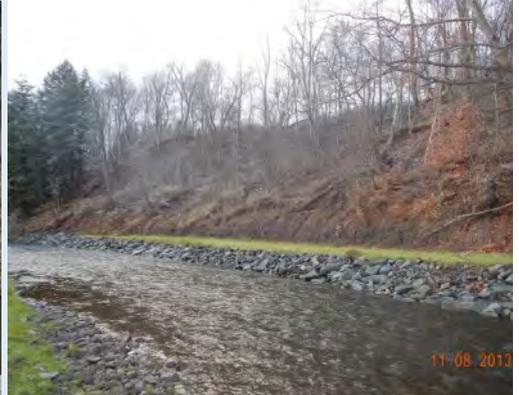
Town of Delhi: Thomson Cross Road (2013)

This project consisted of streambank repair along Thomson Cross Road on the Little Delaware River. To protect the eroding streambank, rip rap was buried along approximately 500 feet of the bank to create a bench. Live willow stakes were planted in between the rip rap. The steep hill slope was seeded and mulched.
